Manhole Inspection Summary

Manhole # S41QQ_028MH

Insp Date: **2/20/07 11:15 AM**

Location Address: **2511 ROBB ST**

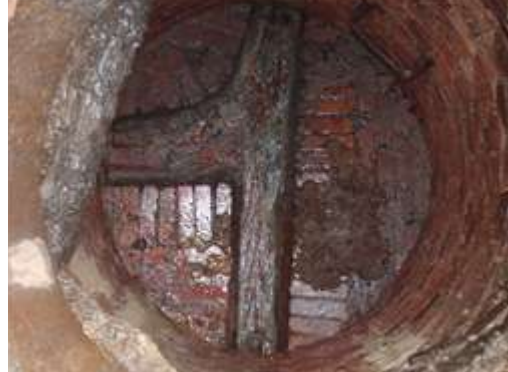
Top View

Corroded and missing steps. Evidence of surcharge - Bench debris.

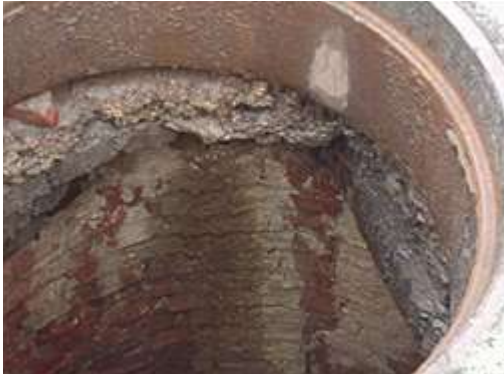
Defect

Frame leaks. Adjustment deterioration and infiltration - other side.

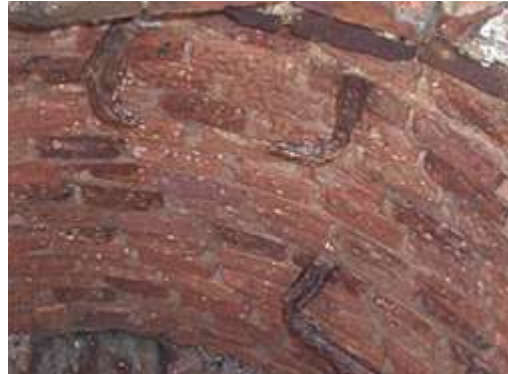
Defect

Corroded and missing steps.

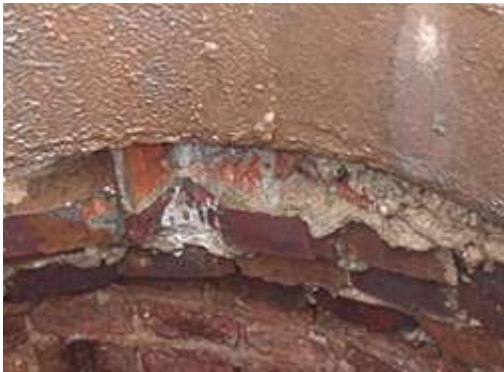
Defect

Frame leaks. Adjustment deterioration and infiltration.

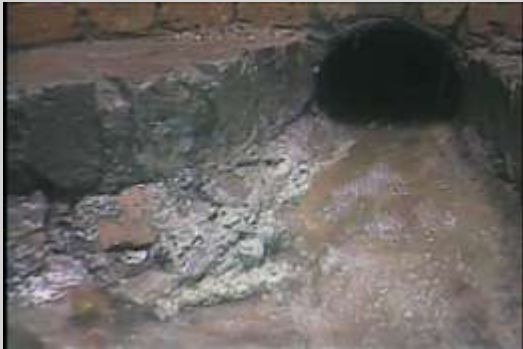
8 in. Circular Gravity Sewer Pipe Out @ 12 O'Clock

Channel deterioration. Channel debris.

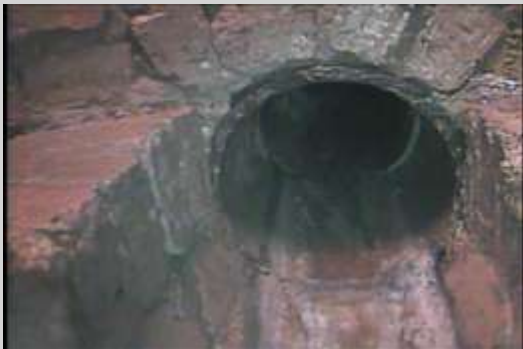
8 in. Circular Gravity Sewer Pipe In @ 6 O'Clock

Barrel deterioration.

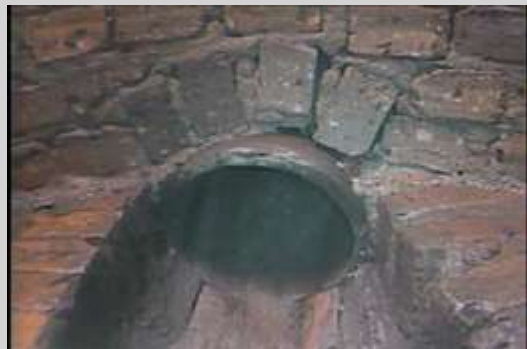
Pipe In @ 9 O'Clock

Barrel deterioration and infiltration.
